## Vehicle Falling from Raised Lift to Ground

<b>SHIELD NUMBER</b>	<a href="#">34815</a>	<b>Date of Incident</b>	15/08/2016
<b>Incident Type</b>	Near Miss - Equipment	<b>Incident Rating</b>	<b>P1</b>

### Incident Description Summary

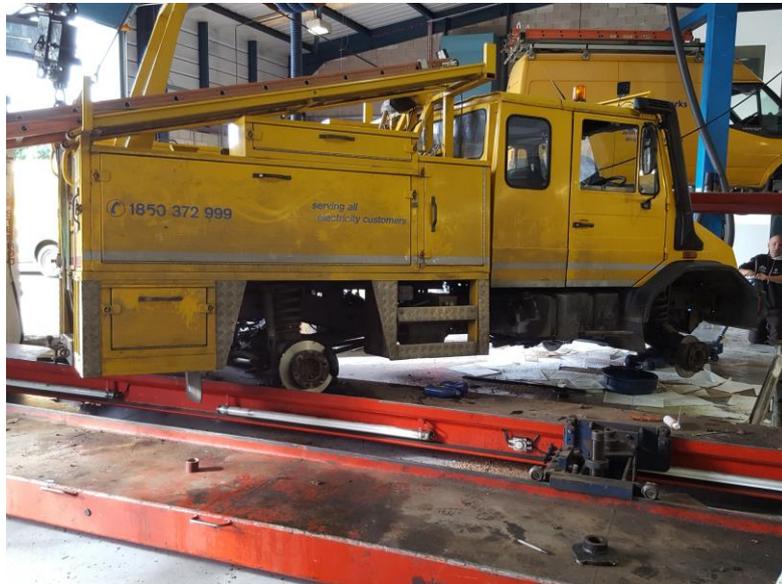
Mercedes Unimog slipped off a jacking beam and fell to ground while being raised on a 20 ton Stenhoj four post lift in a Fleet & Equipment garage. The lift was fully raised to facilitate cleaning of the garage floor when the incident occurred. No injuries were sustained and the local staff made the site safe. This Incident is currently under investigation.

- Where jacking beams are being used, axel stands shall be used as an additional control.
- Always carry out pre-use checks on all lifting equipment prior to use.
- Ensure vehicles are stable and secure before carrying out works.
- If unsure where to support vehicles seek advice from an experienced colleague
- Report all Safety Incidents to your supervisor/lead mechanic
