# Safety Bulletin No. 02/2016

## SECURING VEHICLE LOADS

Issue date	29 February 2016
Issued by	Vincent Cranny, Head of Health, Safety & Environment
Applicable to	All employees who drive commercial vehicles

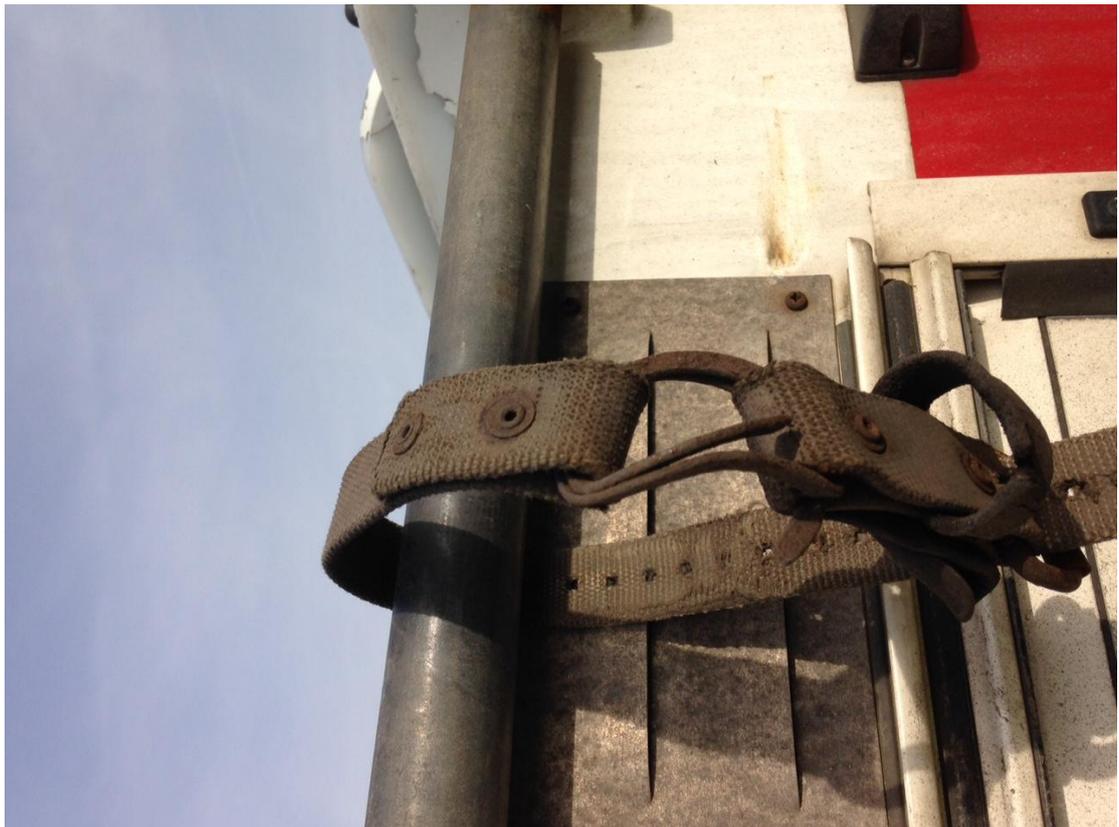
The initial investigation into the incident has found that only one securing strap had been used and it is believed that this then failed.

Securing straps should be checked as part of daily vehicle checks. **Any securing mechanism showing signs of fatigue / damage should be replaced immediately.** The photograph below is a securing strap from the same vehicle and is an example of a strap that should have been identified as unfit for service and replaced.

All employees who drive commercial vehicles are reminded to use the correct procedure in securing ladders, **using a minimum of two securing points.**
