SAFETY FAMILY IN ACTION

Loose MEWP securing Pin – Vehicle Checks prevented incident

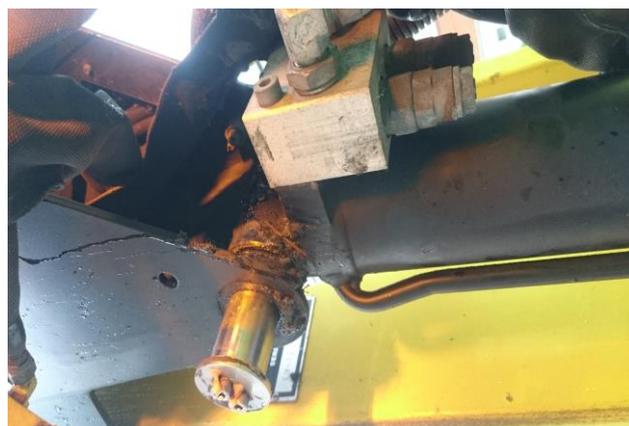
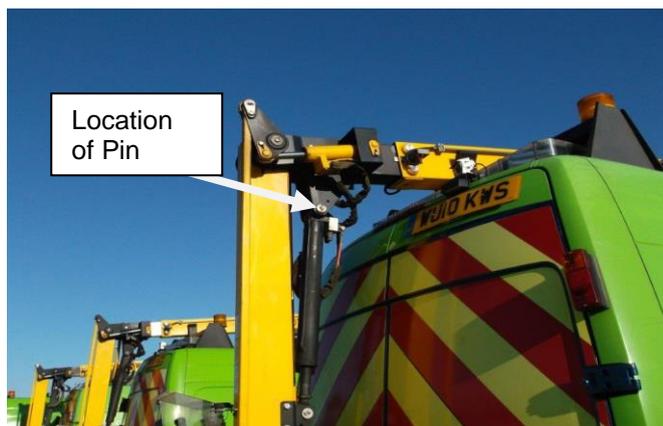
The Driver was carrying out his daily checks and noticed that the boom securing pin on the joint between the boom and the fly Boom had worked loose whilst driving the previous day.

- While driving between locations a securing pin worked loose.
- The driver was carrying out his daily Checks on his MEWP which highlighted the issue.
- The vehicle in Question was a Mercedes Sprinter long wheelbase MEWP
- A Fitter was called who rectified the fault.

Everyone: Mobile elevated work platforms **MUST** be checked for the same issue company wide and continue to carry out vehicle checks before use.

Supervisor: Ensure that all staff are briefed to check for the same faults before the vehicle is used.

Manager: Promote High standards of Vehicle checks and highlight the importance of completing them.
