Safety Bulletin No. 1/2015

Inadvertent operation of switchgear.

Issue date	20 May 2015
Issued by	Dan Garner
Applicable to	Engineers and Craftspeople

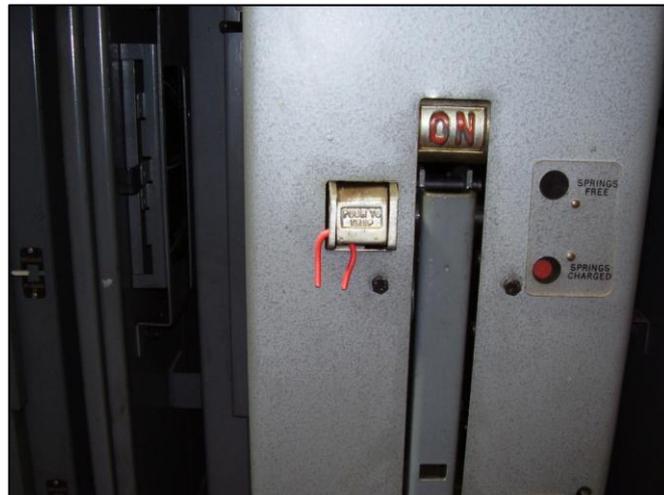
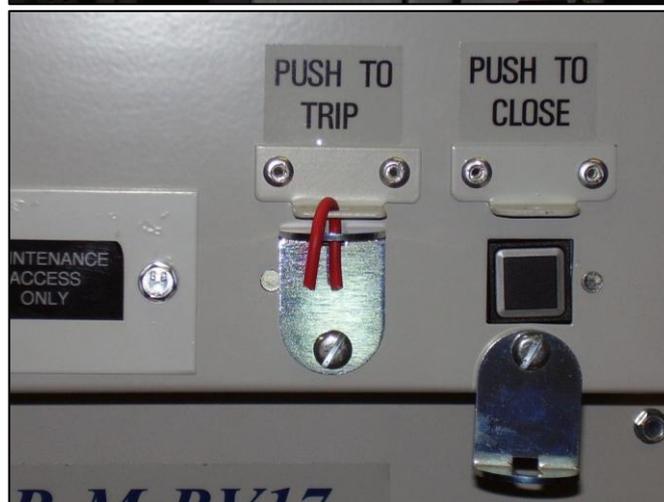
At a number of sites, the switchgear has been found with the wire loop used to keep the trip mechanism shrouded, has been removed.

Where a mechanical trip device is not shrouded and there is a risk of inadvertent operation, a short u-shaped length of red or black covered wire may be inserted in the padlock facilities, where one exists. Where a mechanical trip device is fitted with a cylinder lock, this may be left locked to prevent inadvertent operation, the key being left in the lock.

Staff are reminded that this shrouding prevents inadvertent operation of the switchgear, and should be replaced after use.
