SHE ALERT

Potential to be worse: LV capped end flashover

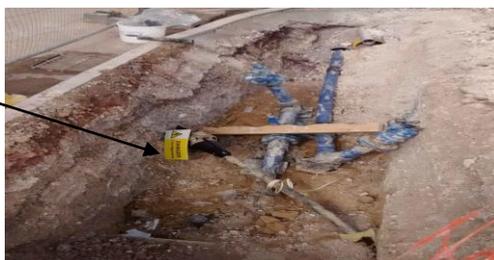
Appendix 1

Whilst installing a water main in a trench excavated by the developers our contractor caused a flashover from an adjacent cable situated in the excavation. This cable was not on any utility plans and the contractor assumed it had been recently laid as part of an ongoing utilities installation. The cable’s position was questioned by the team but they did not escalate to developer or SSE. The team also failed to follow process and confirm the cable’s status using approved processes or suitable detection equipment like a Cat & Genny.

During the connection of the water pipes, the energised cable was disturbed resulting in a flash over at the cable end. (See Appendix 1) This flashover caused a fire, resulting in the plastic water pipe also catching fire. The operatives had to get a fire extinguisher and extinguish the flames. Thankfully there were no injuries on this occasion but there was potential for serious injury or even a fatality.

- Set High Standards and ensure all cable installations are correctly recorded on site and within our GIS system
- Confirm operative understanding of the Earthed Capped End procedure. (LV-JI-900) Note: This cable had a cold shrink cap fitted during installation and the cable incorrectly made live with that cap still in place.
- Discuss the potential for harm in your Toolbox Talks or Setting to Work meetings.
- Ensure there is strict adherence to all procedures & agreed methods of work.

- Challenge your colleagues, check all cable positions and confirm when installed with the site.
- Confirm all site plans are up to date and discuss this with the developer.
- Check “As Installed Plans” are added to the GIS system using the green label system in place.
- If you find a problem, STOP and seek additional guidance from your line manager before commencing work.
