# SHE ALERT

## Unintentional release of methanol to bund

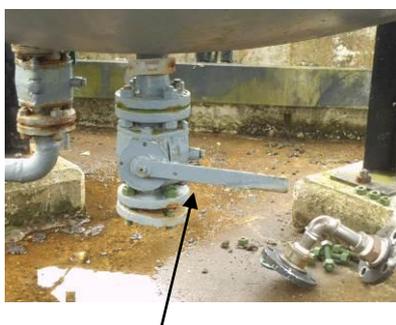
Figure 1: Handle indicating valve closed.

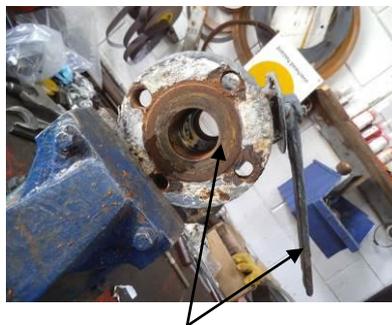
Figure 2: Handle in closed position but open path through valve.

The incident investigation showed that during a previous modification or maintenance, the handle on the valve had been inserted onto a square shaft at 90° to the position that it should have been (see figure 2). This meant that the handle indicated that the valve was closed, however in reality it was open.

- Ensure that the PPE worn for the task is as required by the COSHH assessment.
- When isolating similar valves, i.e. those with a square shaft where there is the potential to install the handle at 90° to the correct position, confirm the valve status by checking the markers on the shaft (see figure 3).

- Ensure that all Safe System of Work (SSoW) requirements, including an instruction to undertake the task is in place prior to commencing work. Where appropriate, ensure that the instruction captures the need to verify the valve status by removing the handle.

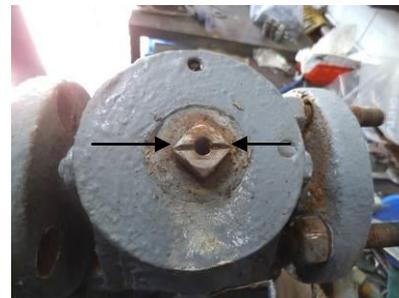
Figure 3: Shaft marker (with handle removed) identifying valve in open position.
