FITTER SUFFERS BURN FROM GENERATOR

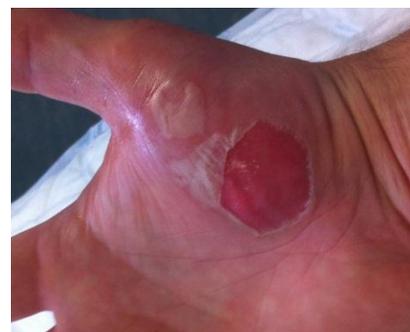
A SPEN fitter carrying out a switchgear replacement has suffered burns to his hand. After removing the oil from the old equipment he was removing oil lines and disconnecting the generator when in an effort to steady himself and gain purchase on the plug, placed his hand on the hot exhaust of the generator. He received burns to his right hand which required him to attend hospital to have checked out and subsequently dressed.

Injury to palm of Hand

He was correctly wearing a pair of Nitrile gloves to protect from the oil he was handling but these offered no protection from heat and in fact may have exacerbated matters by reducing sensitivity to heat and delaying reaction time.

- All generators should have indication to highlight hot surfaces which have the potential to cause injury. If you have such a generator without any warning signs it shall be returned to GAP, this can be arranged through your Team Leader and GAP service depot.
- Ensure you wear the correct gloves for the task being undertaken and be aware of their limitations.

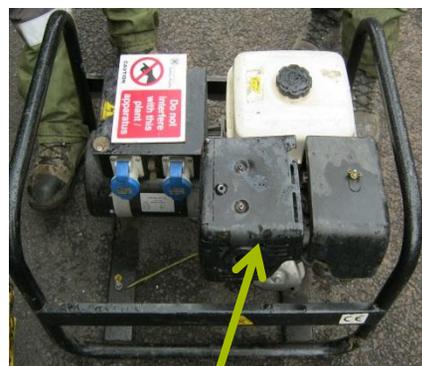
Exhaust with imprint of glove

There was no clear visual indication warning that the surface was hot.
