Vegetation Contractor Fall from Height

On the 7th September 2020 at approximately 10:45 a vegetation contractor working for SPEN in the SP Manweb licence area fell approximately 10 metres from a tree he had been working in.

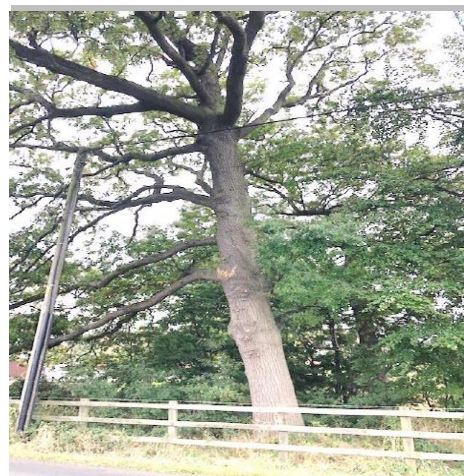
The IP had been using two climbing systems to ascend the tree and carry out the cutting work. While descending the tree after completing the work, the two systems the climber was using for anchor points became detached from his harness resulting in the fall.

Injured person fell approximately 10 metres

- All persons carrying out tree climbing operations must follow [HSE document AFAG401](#) 'Tree-climbing Operations'
- Climbers must be securely attached to two anchor points at all times
- Ensure all working at height equipment is checked before use and is being used correctly as per manufacturer's guidance
- All staff must be trained and competent on the use of mechanical devices for climbing operations

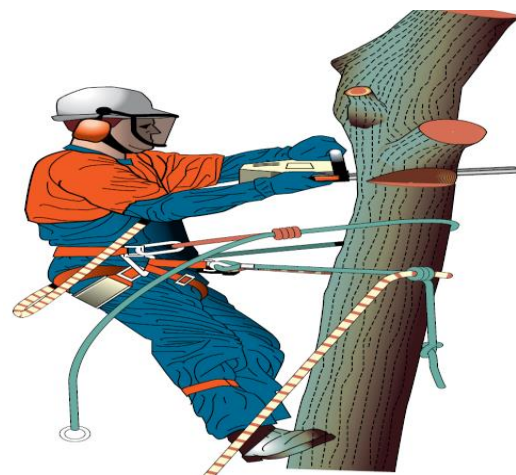
All climbers must have two points of attachment at all times
