For issue to Scottish and Southern Electricity Networks (Employees and Contract Partners)

SHE COMMUNICATION

OVERTURNED EXCAVATOR

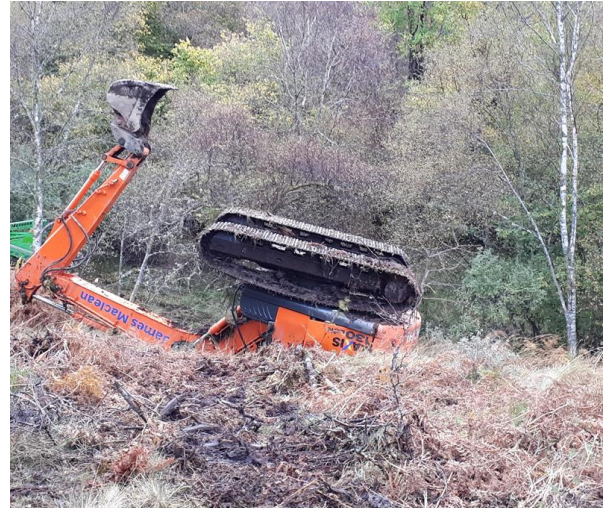
When leaving the site at the end of the day, our contract partner owned and operated 13t tracked excavator was following a tracked MEWP down a planned route when the excavator started sliding sideways down a slight decline (gradient 10° - 15°). The operator immediately lowered his bucket to ground (as trained) but this did not prevent the excavator slowly slipping down a steeper sideways decline (gradient 40° - 45°) for approx. 7m. In doing so, the excavator gathered significant debris under the lower track causing it to overturn.

The operator was wearing his seat belt and took the correct action to sit tight and isolate power to the machine. No injuries occurred and no fluids were lost from the machine. The excavator was safely recovered from site.

The moss-covered access track (used all day) had compacted exposing debris and branches, which lined up with the tracks of the excavator. This, along with wet conditions and the decline in the slope, caused the excavator to slide.

- Could this have happened to you and your team?
- Do you **plan, scan and adapt** to changing environmental conditions and continue to assess risks throughout?
- Is everyone **competent** for their task(s) and know how to apply the correct emergency procedures to prevent further escalation of incidents?
- Do you expect the unexpected? How have you ensured everyone is positioned out of the potential line of fire when working with any plant or equipment?
