# HSE Alert Form

Alert Number: 2015.14

<b>eSafe No</b>		<b>Location</b>	Ergon Energy Wide	<b>Date</b>	8 May 2015
<b>Responsible Business Unit</b>		Whole of Business		<b>Supervisor</b>	-

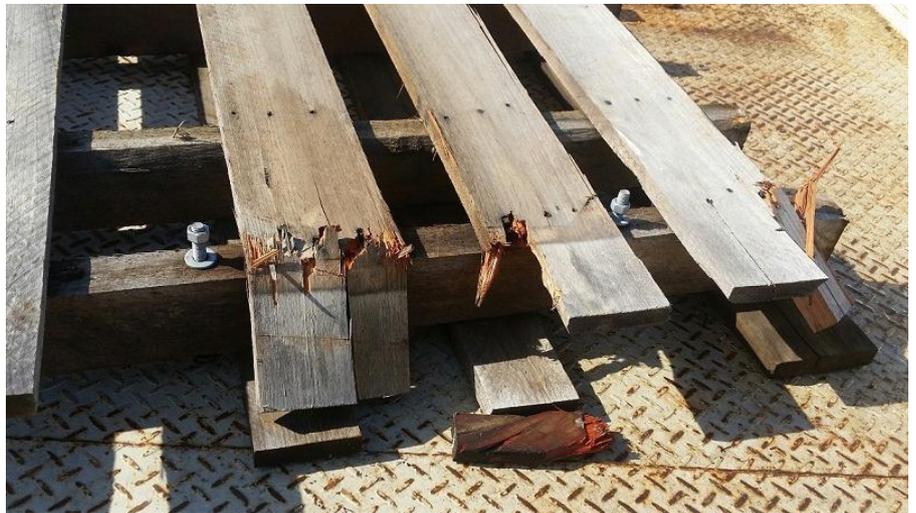
A recent incident resulted in a transformer falling over during transport on the back of a truck. This incident involved a new transformer that was delivered to the field in preparation for a job. At the job site, it was ascertained that the transformer was not part of the fault and therefore required transport back to the depot. The transformer was placed back onto the "transportation type pallet" for transport to the depot but was not bolted back onto it as when delivered from the manufacturer.

The incident resulted in the transformer breaking a bush and an oil spill which escaped from the truck onto the road and required external clean-up assistance from the Queensland Fire Service.

Transformers are bolted or screwed onto pallets when they are delivered from the manufacturers. The pallets are not designed to support the weight of transformers unless they are secured to the pallets by the above method.

Any movement during transport or the improper placement of the transformer has potential to dislodge it during transport.

Managers/Supervisors to advise all Ergon Energy employees managing the transportation of oil filled equipment to follow the requirements stated in [ES000904R113 Management of Fuel and Oil Field Instruction](#), reinforcing the following points.

- Assess equipment for potential leakage and suitability prior to transport
- Prepare equipment for transport
- Securely tie down oil-containing equipment

In particular, where a new transformer is to be transported using the transformer manufacturer's pallet, ensure it is bolted or screwed onto the pallet that it was delivered on from the manufacturer.

For leaking / damaged equipment you need to ensure containment during transport by the following:

- Decant or drain oil
- Plug any holes or leaks
- Use SpillGuard type pallets
- Cover with a pallet bag
