Safety Gram

Safety Gram No. 10-03

Whilst operating a Gevea Hv switch with a standard 10' operating stick with a 5' extension attached, the mechanical interlock between the two sticks failed.

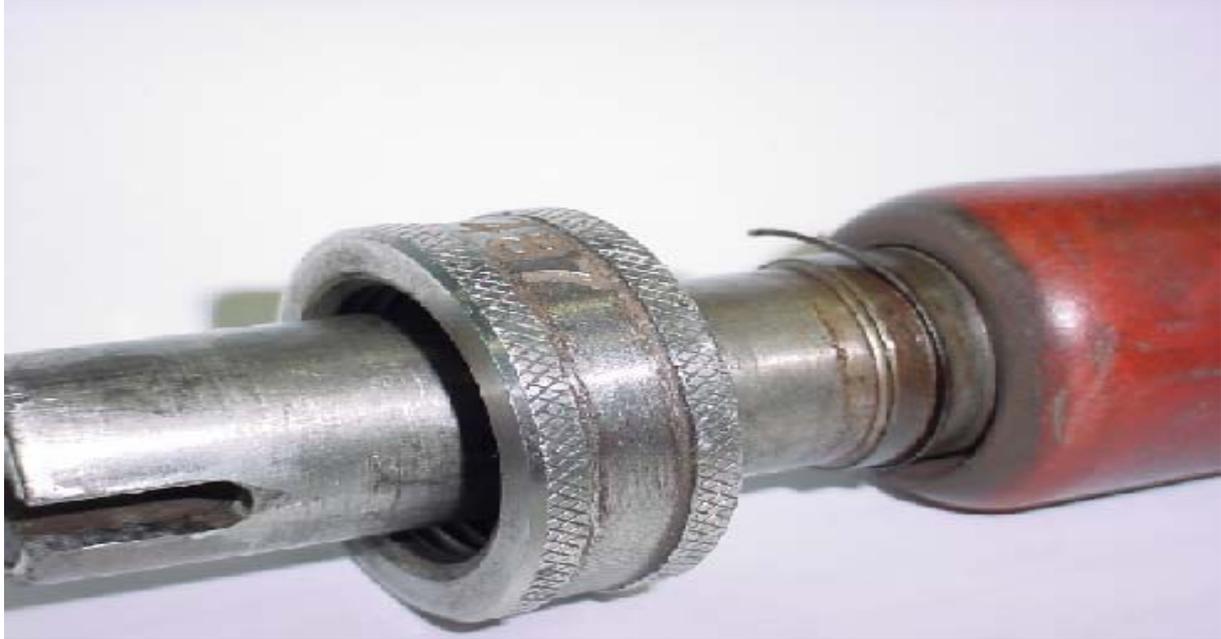
As a result of this failure, the two sticks separated, with the top section falling from height, close to the operator below.

Failure of Circlip securing HV stick interlocking device

HV Operators should carry out on site checks prior to using interconnected HV Sticks to ensure failure of circlip is not imminent.

The head of the HV Stick is to be secured on a solid structure, the operator should then firmly apply pressure to the stick in a pulling motion to ensure the mechanical interlock is secure.

Checks to be carried out during annual HV stick testing
