Safety Advice 02-2005 (NZ)

FLASHOVER

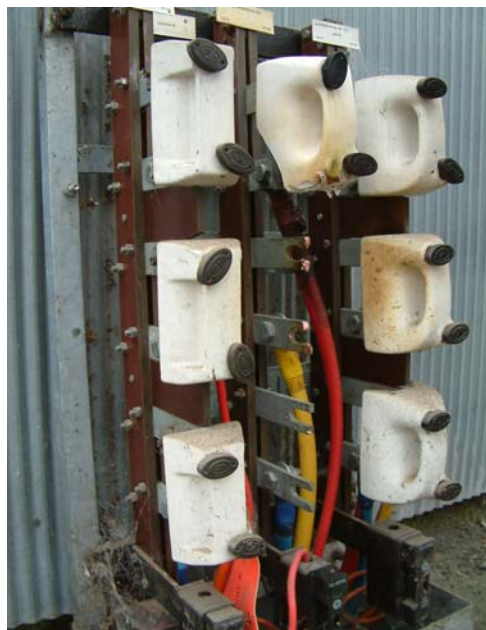
On 8 February 2005, a worker was inserting solid links, as part of a program to install LV ties, into a multi box fitted with an open bus frame. A phase to phase flashover occurred and the worker suffered burns to one arm and his face. He was treated at hospital and discharged the same morning.

All workers should be aware of the potential hazard of exposed live terminals and should ensure that all steps are taken to eliminate, isolate or minimise the hazard.
