Event Number: Maximo #113923

First Alert

Heavy vehicle contacted 400v Service line

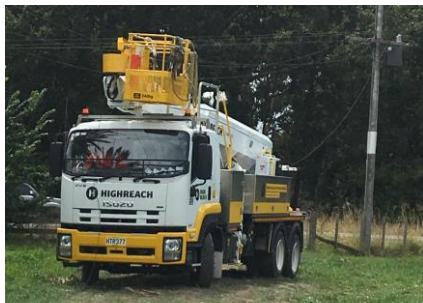
Description of Event: During BPE-HAY reconductoring project, a heavy vehicle has been reversed into a Low live 400v service line supplying a private residence, when there had been a change to the planned access route. The contact caused a conductor to break and fall to the ground.

Picture 1: Truck in contact with wires

Immediate Actions: The Driver remained in the vehicle until the site was made safe. The residents were removed from the property by the site crew and advised to remain clear until the site was made safe. A fault response distribution lineworker was dispatched to the site to make the site safe and repair the damaged line.

Immediate Safety Message: Ensure a full risk assessment of site access is undertaken, to identify and mitigate potential hazards. Carry out a new assessment of the hazards if there are any changes to planned access routes.

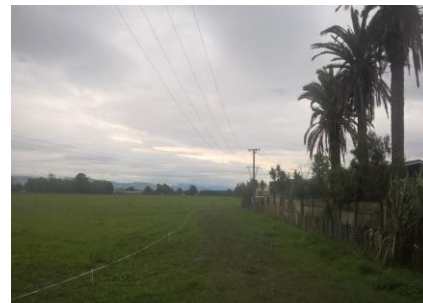
Picture 2: Position of line after repair
