# SAFETY ALERT!

| Subject | Lessons Learnt 3 <sup>rd</sup> party 11KV Cable strike | | |
| Alert Number | SA114 | Date Issued | 13/12/2017 |

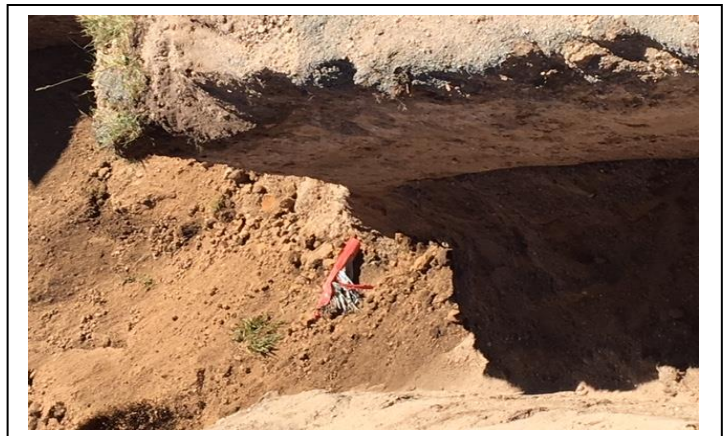
On Monday the 20<sup>th</sup> November 2017 at 12.55pm the Wharewaka feeder at Taupo south opened under fault due to a 11KV cable being severed by a third party 20T Trencher.

- Poor communication received from 3<sup>rd</sup> party – no key point of contact identified
- The area had not yet been marked out digging began earlier than Unison had been previously been advised.
- The plans were incorrect – the cable on the plans were drawn outside of the start location.

1. Unison have met with local stakeholders to discuss the incident and address areas for improvement for clear and accurate communications.
2. Formalise process that key contact is established at the beginning of project.
3. Review of the software and hardware resources provided to cable locators across the Unison network.
4. Cable locate workgroup to be formed to review the process of cable location and create a work instruction to provide consistency across unison work areas.

- When dealing with 3<sup>rd</sup> parties ensure that Unison personnel are provided with key contact details to ensure clear and concise communications.
