# Alert

Health Safety Environment 04-07-2024

## Ute trailer went off track on downhill track

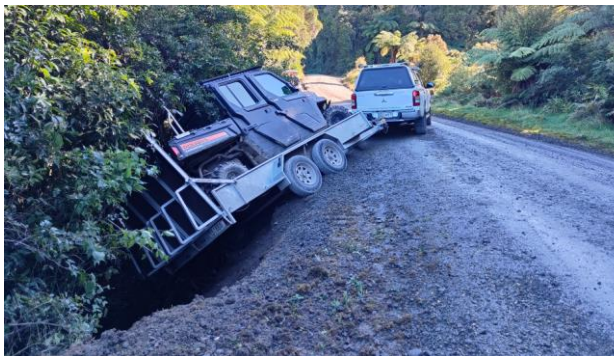
- Ute towing a trailer lost control on wet downhill track.
- One side of the trailer went off the track.
- At some stage the brakes were left in the locked-out position.

Figure 1 Downer trailer loss of control

The trailer brakes had been left in the locked-out position after a previous reverse manoeuvre.  
Management address staff outlining incident, key messages, and learnings.  
Crew Resource Management (CRM) communications to confirm trailer brakes are in the correct position.

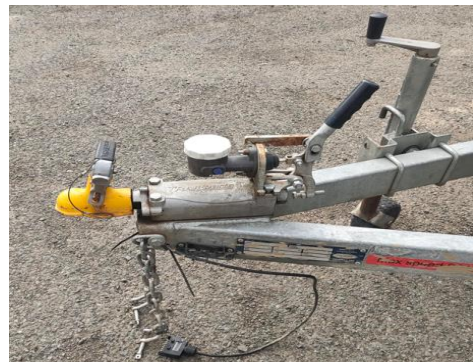
Figure 2 Trailer brake locked out.
