ISSUE No.04
June 2016

SAFETY NOTICE- Line Mechanic Injured when LV Pole broke

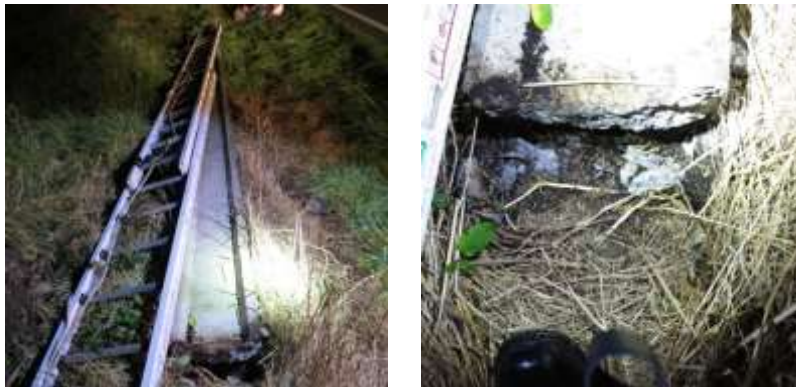
The worker visually inspected the concrete pole adjacent to the pole the car had damaged. The inspected pole appeared sound. The worker ascended a ladder, tied the ladder and secured himself via his pole-strap. On unbinding the LV conductors, the pole, ladder and worker fell to the ground.

Preliminary inspection of the pole indicates it is of a non-standard type with no steel reinforcing present at the point of failure. The pole had broken just below ground level.
