Deck of Truck Loose on Chassis Mounts

EVENT

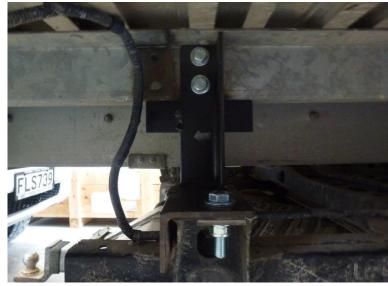
Underside of Truck Deck

While a vegetation crew were spraying access tracks, the weed spray unit on the back of the flat deck unit lurched forward and the deck became loose on the chassis mounts.

On closer inspection it was found that the rubber bushes and bolts holding the deck onto the chassis were worn, which resulted in the forward movement of the deck.

This movement could affect the handling of the vehicle and also cause the chassis brackets to bend if they were not Subsequent investigations showed the original repaired. brackets were of insufficient strength. They have since been modified.

Chassis Bracket

- To replace chassis brackets, with new brackets of sufficient strength
- To check all chassis brackets on additional trucks in fleet
