# FIRST ALERT

## VDD Proximity tester failed to alert

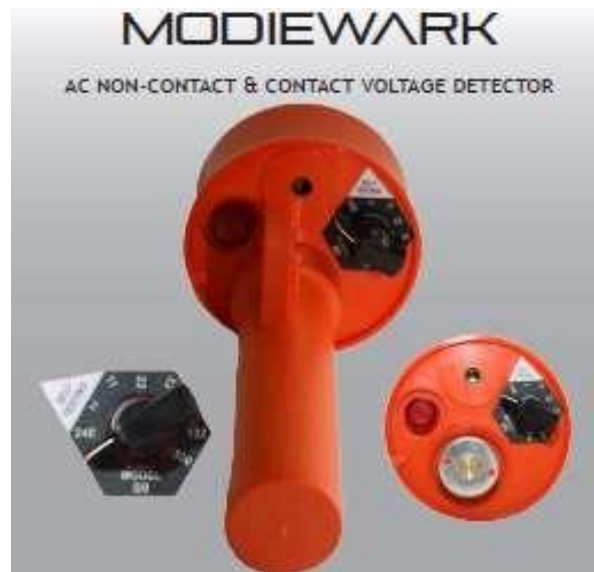
The VDD was put in proximity of the adjacent live circuit. It did not respond. To increase the device's sensitivity, it was switched down to the 66kV setting. It responded with a continuous tone as expected.

Modiewark Proximity Tester NZ Model

- All Cake Commercial Modiewark VDD's were brought in for testing & confirmed to be working correctly.
- Technical expertise has been engaged and an investigation commenced.
- Field trials commissioned to compare the performance of the Modiewark VDD with two other commonly used types.
- Alert the industry by way of this First Alert.
- Follow up with a Safety Alert with results and conclusions.
