# Incident Alert

Technician receives electric shock from super-imposed DC voltages

02 August, 2015

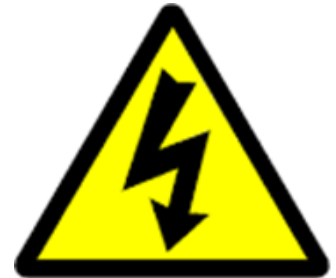
On arrival the Technician found that 110V DC chargers measured -250V to earth on the positive side and -350V DC to earth on the negative side. This is a most uncommon fault situation.

The Technician was diagnosing the high voltage potential as per the test and measure configuration shown in the diagram. The Technician inadvertently contacted a live potential from a test lead when making the test circuit connections at the same time holding the metal frame of earthed test apparatus. He therefore received an electric shock from one hand touching the conductor through to the other hand touching earthed metal.

- Always ensure you reassess your methodology when you find a situation that is abnormal.
- Ensure test configurations are assembled in such a manner that unattached leads cannot be energised.
- Ensure incident reporting is expedient and to the correct line management regardless of time and day of week.
