FIRST ALERT

CB Fail Initiate resulted in a loss of FHL 110kV Bus

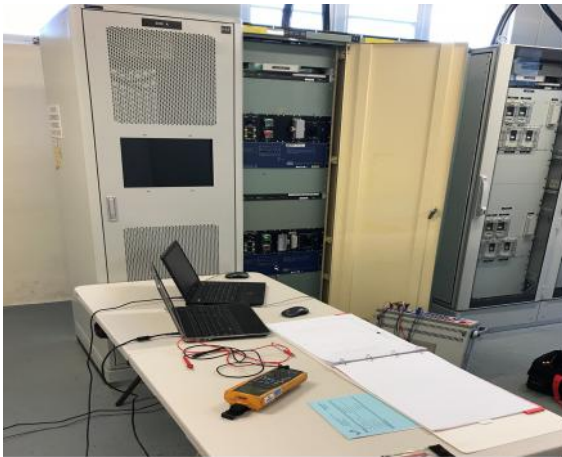
While undertaking scheduled line protection maintenance at Fernhill Substation for CB 152 (FHL-WPW-Cct 1), a CB Fail initiate was triggered resulting in a total loss of the FHL 110kV Bus.

The CB Fail isolation switch (S4) was not selected to isolate before the testing of the protection relay commenced.

There is no bus coupler installed at FHL so on operation of the bus zone protection, a total loss of the 110 kV bus results.

- Broadspectrum management and Transpower were informed and FHL 110kV Bus was returned to service
- The work scene was quarantined and initial investigation conducted on site.
- An investigation is underway.
- On completion of investigation, further updates will be circulated to all Service Providers.
- Technicians are reminded to confirm all intended isolation will allow for safe testing of equipment.
- Where the site has no bus coupler the increased risk to system security needs to be identified at the planning stage and additional planning and/or documentation needs to be implemented.
