# SAFETY ALERT

## Excavator - Near Miss

| Date of Issue: | 29-07-18 | Hazard Alert No: | HA-011-29-07-18 | | |

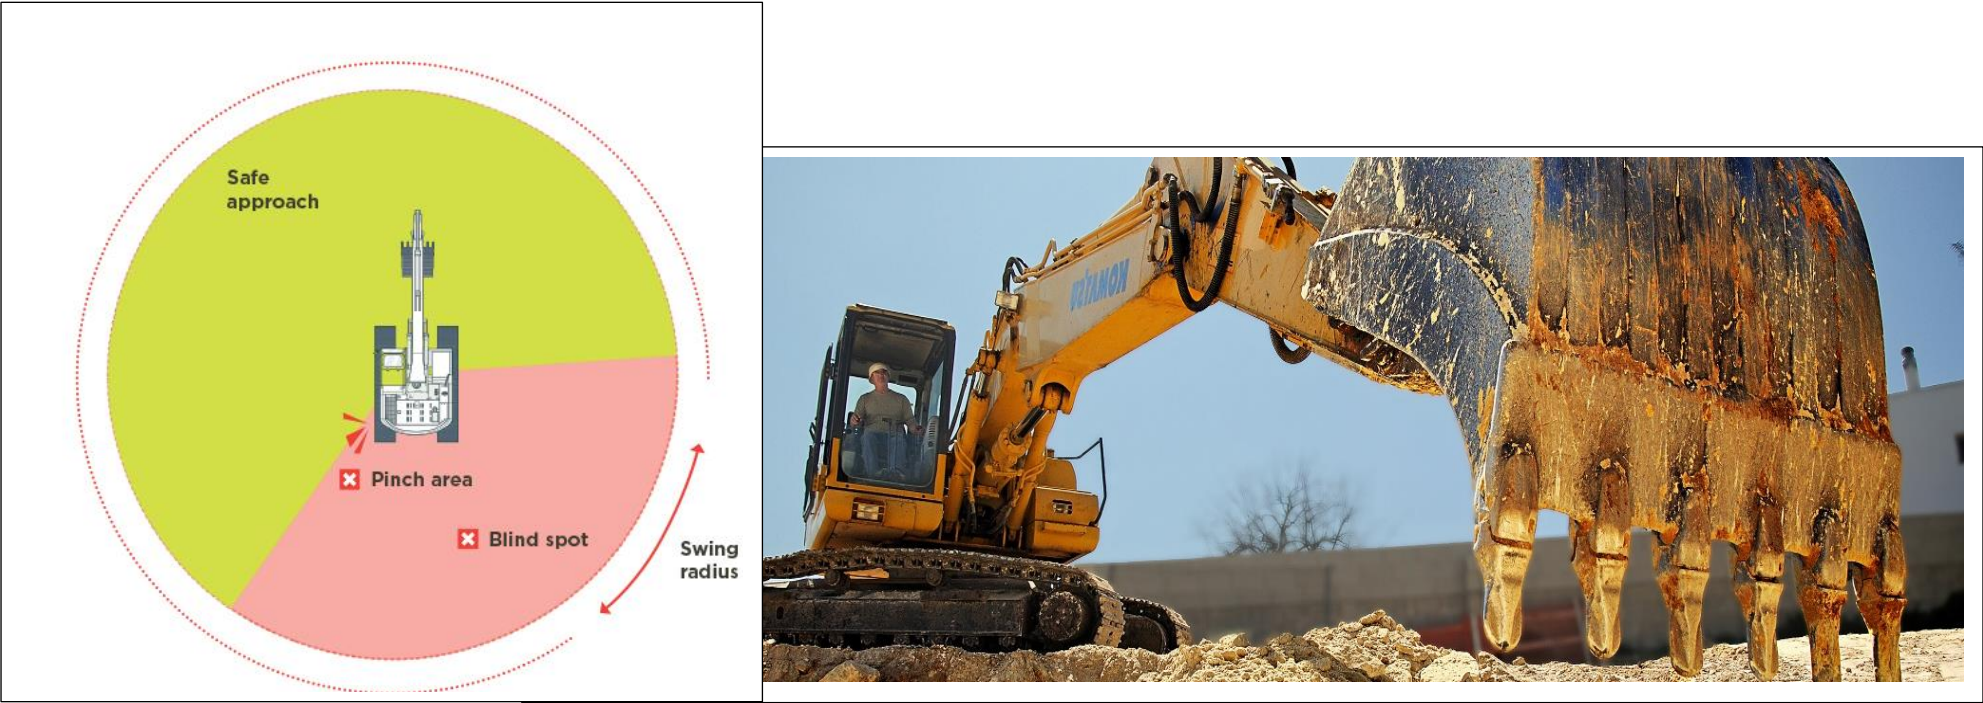
2. Always adhere to exclusion zones when working near to excavators or any other heavy machinery. See the below figure showing exclusion zones when working with excavators.

3. Before approaching any machinery, you must:
  - a) First make eye contact with the operator and wait for acknowledgement that you have been seen.
  - b) Only enter the machineries working zone once the operator has taken their hands off the controls, or activated lock outs.
