# Safety Alert – SA421

## Drop Zone Control

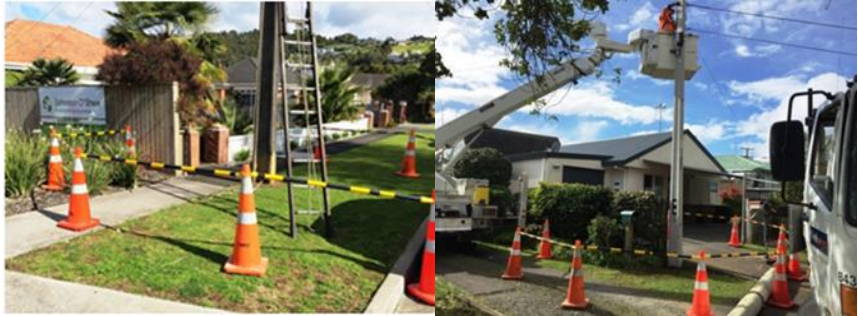
| Incident | Description | | |
|---|---|---|--|
| <i>Actions Required / Messages:</i> | <p>Set up a drop zone around the base of the pole. This should include a physical barrier whenever this is practicable, as in the pictures below.</p> <p><b>No entry into the drop zone is allowed when work aloft is being undertaken.</b></p> <div></div> <p>When it becomes necessary for someone on the ground to enter the drop zone:</p> <ol style="list-style-type: none"><li>1. The ground worker should communicate to the workers aloft and await instruction to enter.</li><li>2. The workers aloft will (wherever practicable) cease work and ensure any unsecured items are controlled. If possible they will move down to a safe position where the risk of dropping an item is reduced.</li><li>3. The workers aloft should then give their permission to enter the drop zone to the ground worker.</li><li>4. The ground worker can now enter.</li><li>5. The ground worker will communicate when they have left the drop zone; allowing the workers aloft to continue.</li></ol> | | |
