SAFETY! ALERT!

Non Essential Work observed while 110kV BZ/CB Fail isolated

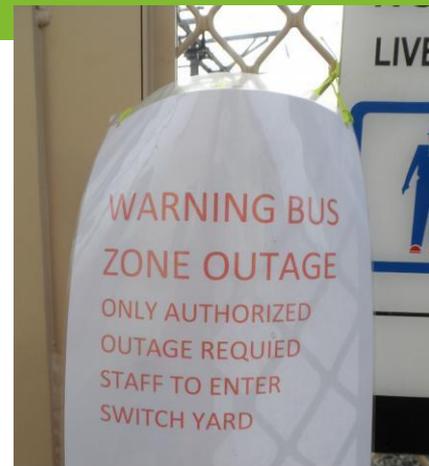
During a 110kV bus zone outage at HWA on the 30-06-17, it was identified that staff not working under the Bus Zone outage were found to be working in the 110kV switchyard under a separate AP while area's of the Bus Zone were isolated. Later this work was stopped because this may impose risk of tripping.

As per service TP. SS 03.00 no work to be carried out within substation while bus zone protection is not in service.

- Work was stopped and personnel not involved with the BZ/CBF outage were instructed to remain outside of the ODS until the BZ/CBF had been restored.
- A stand down of all HWA Project staff was undertaken on the 27th July, where a review of the H & S Practitioners findings was reviewed along with TP.SS 03.00 HV Power System Protection Maintenance, TP.SS 06.56 Work Authority Procedure and TP. SS 07.21 Access Permit and Test Permit procedures.

- Decision not to request the movement of the Bus Zone Outage when faulty equipment was identified the day prior to the planned outage of the Bus Zone.
- Failure to comply with posted signs and notices.

- When change occurs. **STOP, REVIEW, REPLAN, COMMUNICATE** change with work party.
- Warning signs and notices are to be observed – where temporary notices and signs have been put in place they need to show a contact name, number and date the sign was placed.
