Safety Alert – SA242 MTI - Bolt Fell 7 Meters Hitting Worker

Date of issue: 14/08/2014

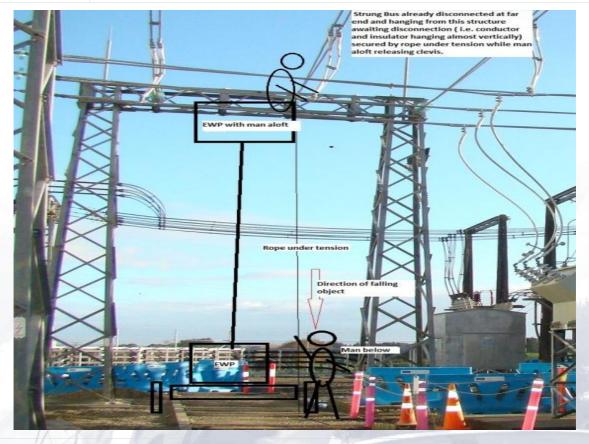
Incident	Description			
Date of Event	12 th August 2014			
Location	Bunnythorpe Substation			
Time	11.30am			
Injuries/Damage sustained	Broken / chipped teeth			
Event Description	While dismantling 33kV Strung Bus (twin Cicada) a clevis bolt had to be removed by force by the worker in the bucket. The worker below was holding the landline under tension to release the conductor and insulator string when the bolt dropped, hitting him in the mouth resulting in a broken front tooth and 2 chipped teeth.

Initial Actions Taken	Work was stopped immediately and the worker was taken into the dentist. The incident was reported to both the client and Northpower's Management with an investigation now underway.
Actions Required / Messages	 It would appear at this stage of the investigation that: Although the worker was required to be inside the work zone there wasn't a need for him to be directly underneath the bucket. There was a lack of communication between the two parties. The JSEA identified the Drop Zone as a hazard and the controls in place were for those below to be aware and the area to be cordoned off. This incident was upgraded to an MTI when it was identified the worker would need ongoing dental treatment.
This alert was released by:	Janine Wagstaff – Mobile: 0274595660
