safety alert

Ningbo Conductor Grip

Electrix Event Number
C17805

The Issue
Cracks found in Ningbo aluminium conductor grip

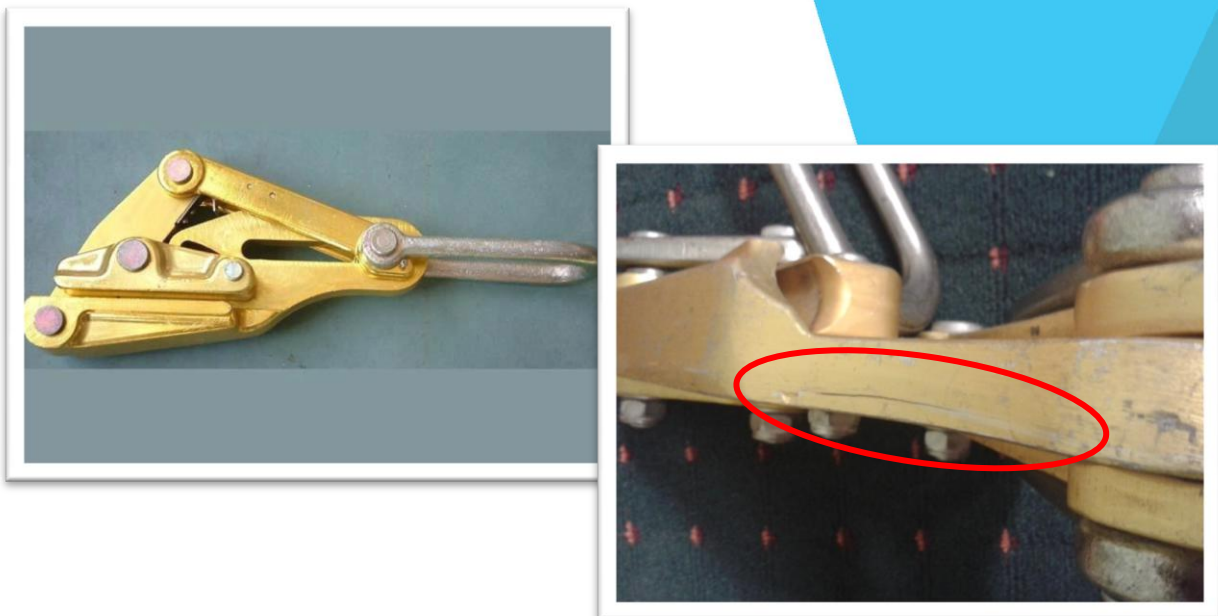
What Happened
During inspection of aluminium conductor grips two were found to have small cracks in the body of the grip.

- Defective conductor grips removed from service
- Quarantine of all aluminium body conductor grips, subject to checks for damage/cracks
- Source replacement steel conductor grips
- Sample test (NDT - ultrasound, crack test) remaining grips for signs of defects
